PANBOWL LAKE

City of Jackson, Breathitt County

KENTUCKY
TRANSPORTATION
CABINET

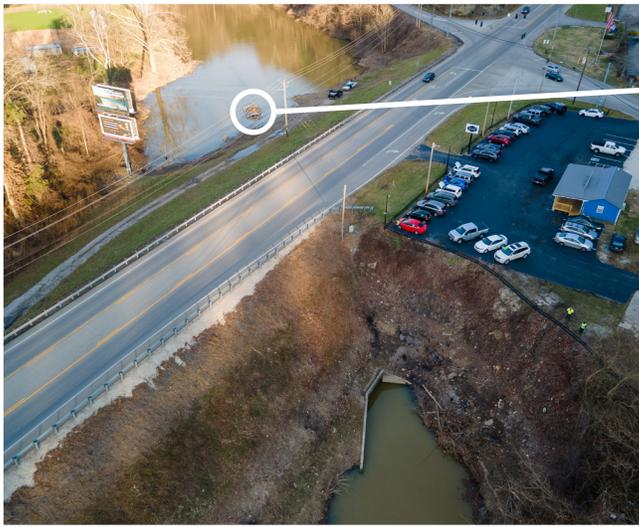
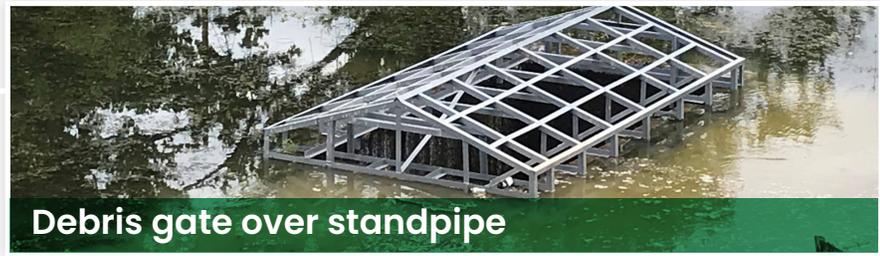
EAST EMBANKMENT

Debris gate over standpipe

The east embankment has the only drainage structure for Panbowl Lake, a standpipe riser connected to a concrete culvert under KY 15. The top of the standpipe has an elevation of 713 feet and helps keep the water in Panbowl Lake at this same level.

- ▶ Replace debris gate over the east embankment standpipe
- ▶ Remove vegetation along the embankments
- ▶ Install sheet pile wall
- ▶ Flatten slopes
- ▶ Replace Washington Avenue flap gate and add a secondary gate
- ▶ Install drawdown valve at the east embankment
- ▶ Widen Kentucky 15

Vegetation along the embankments has been removed, which will allow for easier access and inspection of the dam. The debris gate over the standpipe at the east embankment was replaced in July 2021.

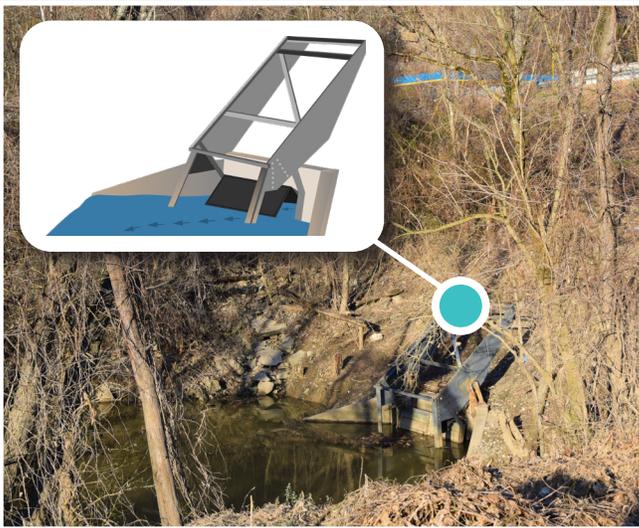
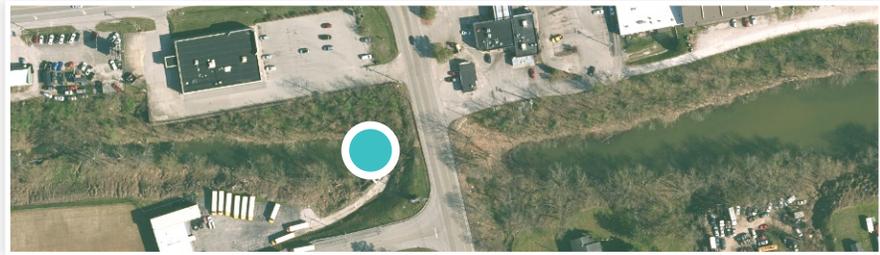
OUTLET CHANNEL AND FLAP GATE

Excess water from the lake flows from the east embankment culvert along an outlet channel that runs parallel to KY 15 and under Washington Avenue. A flap gate helps prevent water from back flowing from the North Fork of the Kentucky River to the lake.

The widening of KY 15 and Washington Avenue will include replacing the flap gate and implementing other recommendations. Construction is anticipated to start in 2024-2025. The widening project will involve putting fill material into the lake to support the new KY 15 embankments and extended culverts. The engineering study determined that this added material to Panbowl Lake would not cause a significant impact to the overall water capacity of the lake.

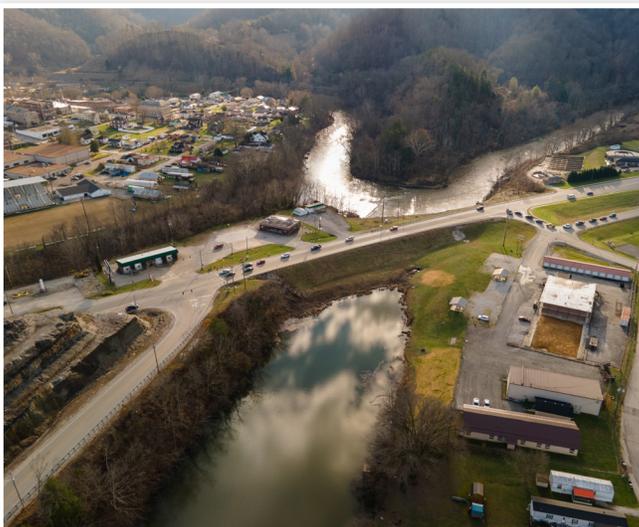
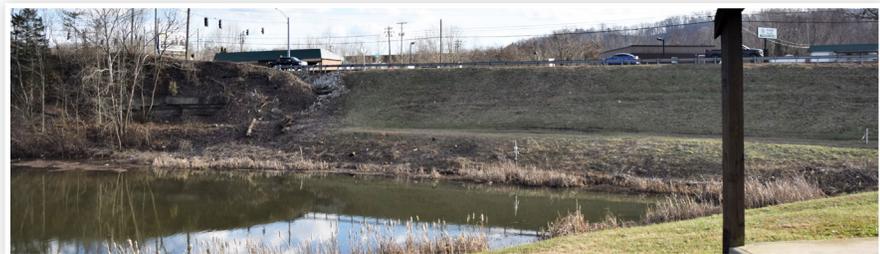
WEST EMBANKMENT

The west embankment separates the river from Panbowl Lake. Like the east embankment, there are different slope measurements on either side of the road. Fill material in the embankments includes topsoil, asphalt, rock, coarse grained alluvium, bedrock, shale/sandstone and groundwater.

Water from the river seeped through west embankment, causing water levels on the lake to rise to an elevation of 728.9 feet (16 feet above normal). This caused a slope stability issue, but the Kentucky Division of Water Dam Safety determined that KY 15 could remain open to traffic and there was no threat of the dam breaching.

With approved funding, sheet piling (metal retaining wall) will be installed at the west embankment in summer 2022 and rip rap (heavy rock) will be added to strengthen the slopes.

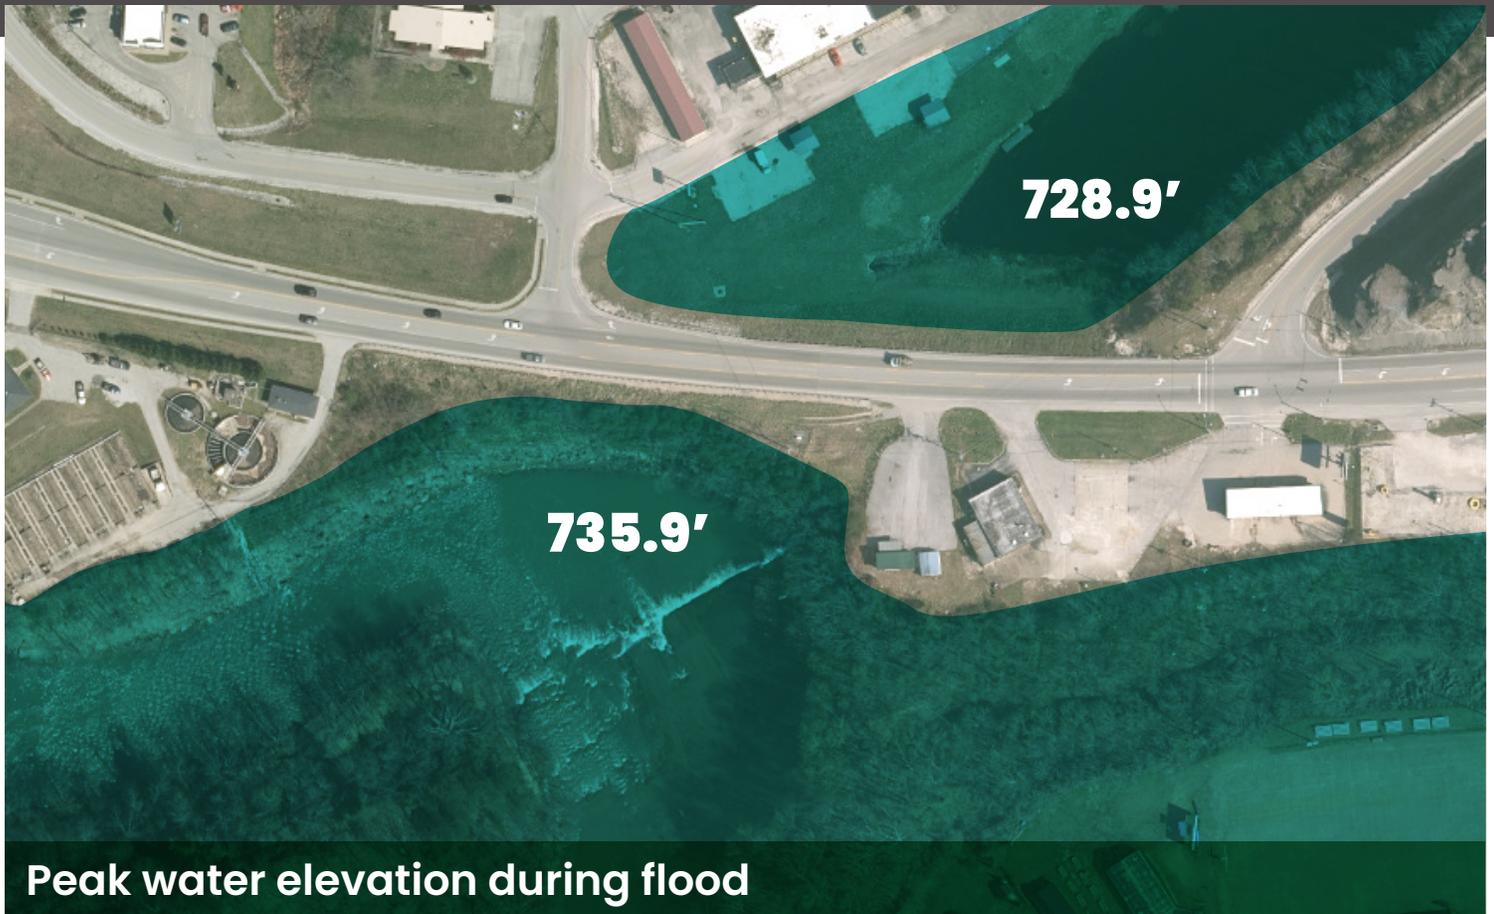
In late February and early March 2021, rain and runoff into the North Fork of the Kentucky River caused water levels to rise dramatically in a short amount of time. The river crested on March 1 at an elevation of 735.9 feet. The flood was the 10th highest flood in Jackson's history and the worst since 1984.

Peak water elevation during flood
